## Perform Guard No. 6012

**Subject:** Testing Update

**Date:** January 2008 (Revised January 2019)

Foam-Control® developed a full scale research program in the 1990's to determine the effectiveness of Foam-Control with Perform Guard when exposed to termites.

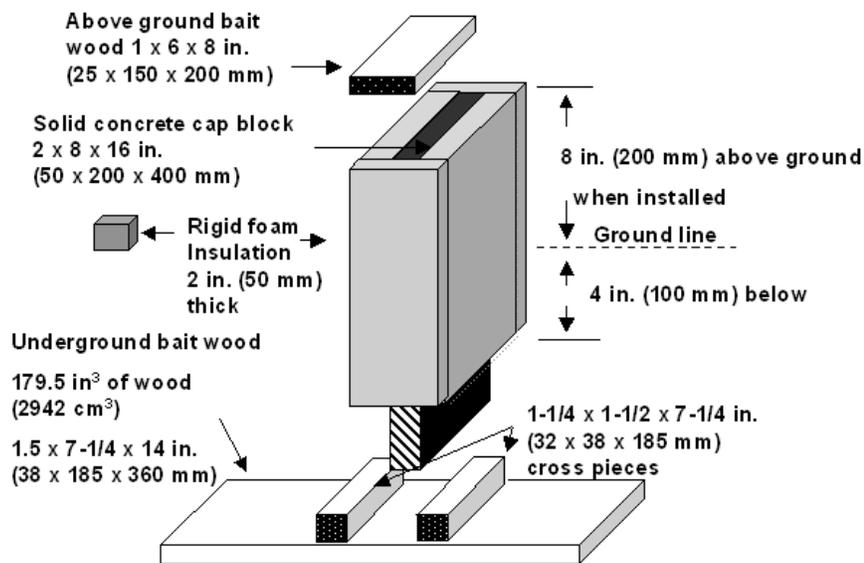
Figure 1. — Schematic showing construction and installation details of test unit used to field test rigid foam insulation with untreated aboveground and below-ground baitwood pieces to attract termites. Each insulation piece was bonded to concrete or insulation with a continuous layer of untreated or borate-treated construction sealant.

**Test units.** — A test unit was a solid concrete cap block with 12 inches (300 mm) of EPS bonded flush with one end of the block on all four surfaces by a continuous layer of either treated or untreated CS. **Figure 1** shows the components and how a unit was installed. Installation was completed by an opaque plastic cover that provided protection from weather and the dark conditions that termites prefer for tunneling activities. A 3/8-inch- (10-mm-) diameter hole in each narrow face provided ventilation to reduce condensate moisture. A southern pine sapwood stake, 3/4 by 1-1/2 by

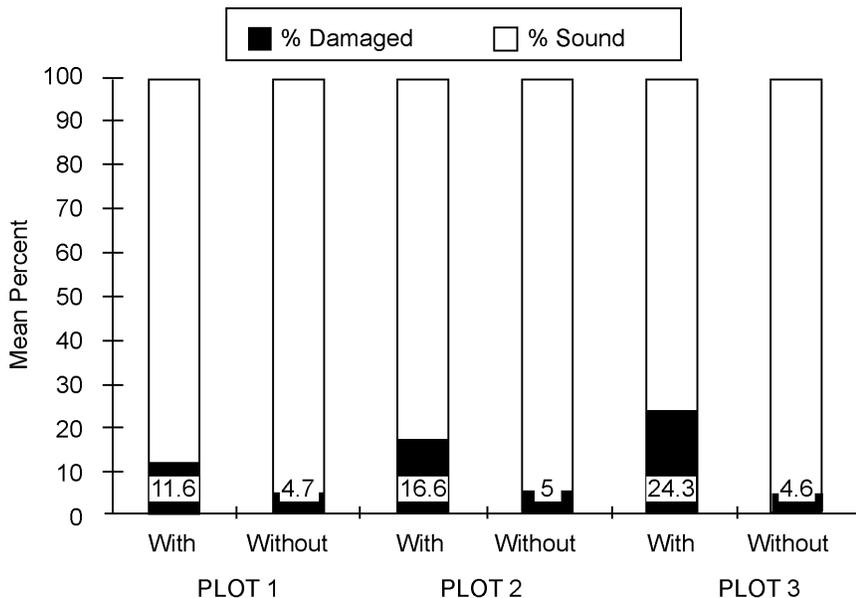
Figure 2. — Mean percent sound and damaged expanded polystyrene in samples with and without visible termite damage from each of three plots when images were analyzed following 3 years of field exposure.

*Characteristics.* — For 720 analyzed images, 375 had visible termite damage, 345 did not. Estimates of damage including apparent damage from CS and/or identification labels for the 375 samples ranged from 11.6 to 24.3 percent, by plot (Fig. 2). For the 345 images without visible termite damage, the mean ( $\pm$  standard deviation) estimated damage was  $4.8 \pm 1.8$  percent. This error factor

associated with image analyses was essentially the same for each plot (Fig. 2).

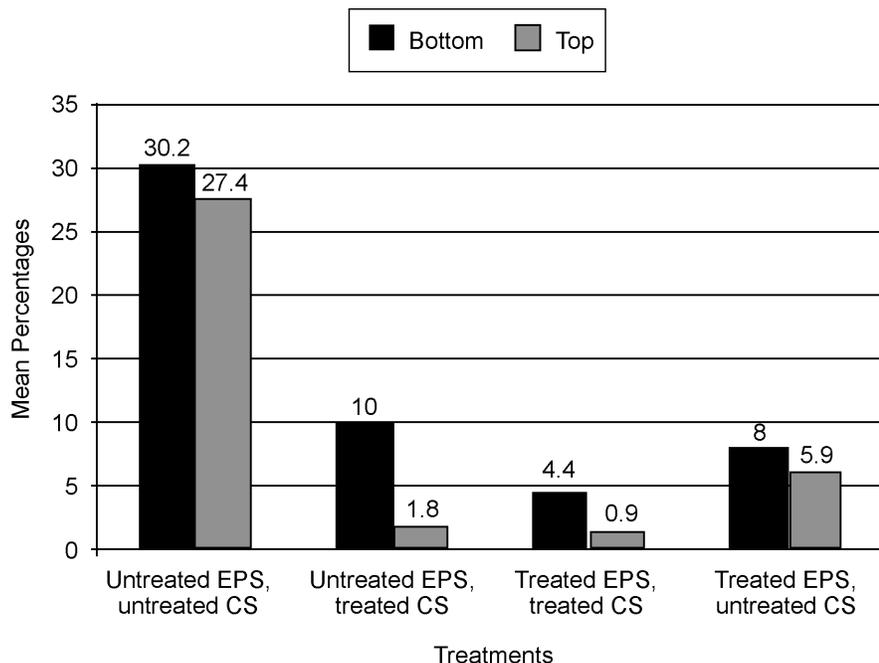
Figure 3. — Mean percentages of termite-damaged insulation per treatment for bottom and top samples of units in all plots after 3 years of field exposure ( $n = 60$ ). Means shown are after subtraction of an error factor associated with image analyses of 2.7 for bottom and 3.4 for top samples:  $n$  for error factors = 28 and 145, respectively.

Analysis was conducted to compare the damage to the top part of samples with that in the lower or bottom part of the sample. Damage to the top region would indicate significant tunneling throughout the EPS. Mean percentages of damage for all plots were always higher for bottom samples than top samples for all treatments (Fig. 3). This was true across all plots and in each plot. For untreated EPS and untreated CS, damage was 30.2 percent for top samples and 27.4 percent for bottom samples. However, damage was 0.9 percent for top samples and 4.4 percent for bottom samples from units with treated EPS and treated CS, indicating that termites were only making exploratory attacks at the bottom of treated EPS pieces adjacent to the large underground baitwood. When

only EPS or CS was treated, damage to top samples was from 8.0 to 10.0 percent and damage to bottom samples was from 1.8 to 5.9 percent (Fig. 3).
